OBJECT: NEW HP POPPET SEAT FOR MR FIRST STAGES (CODE: 46186216)

THE TECHNICAL ASSISTANCE DEPARTMENT OF MARES S.P.A. ANNOUNCES A MODIFICATION TO THE PROFILE AND MATERIAL OF THE HP POPPET SEAT USED IN ALL OF MARES MR FIRST STAGES.

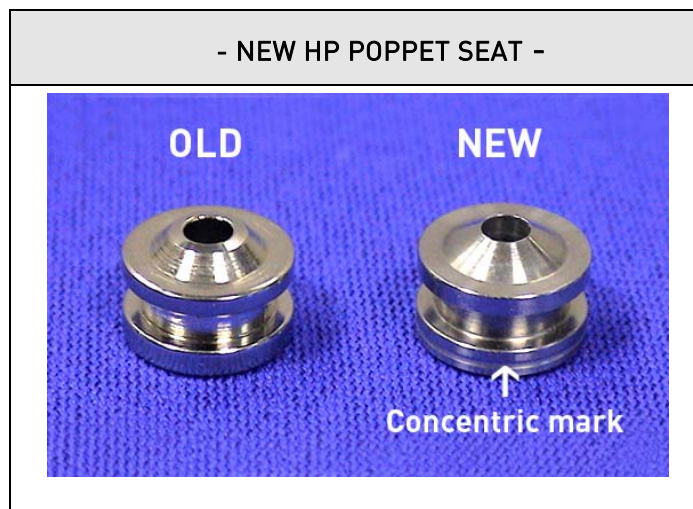
PICT.1

THE NEW HP POPPET SEAT WAS DESIGNED AND TESTED TO GUARANTEE A GREATER RESISTANCE TO WEAR AND TEAR. THE NEW HP POPPET SEAT SHOULD ONLY BE USED WITH THE TRI-MATERIAL POPPET, (CODE: 46200652)

THE NEW HP POPPET SEAT CAN BE EASILY IDENTIFIED BY THE RADIAL THROAT DESIGN UNDER THE SEAT OF THE OR-RING (AS SHOWN IN PICTURE 1 BELOW).

DO NOT ATTEMPT TO USE THE NEW HP POPPET SEAT WITH MARES OLDER STYLE RUBBER POPPET (CODE: 46185002). THE PROFILE OF THE NEW HP POPPET SEAT CAN DAMAGE THE RUBBER POPPET SURFACE CAUSING A FREE-FLOW.

FOR DISASSEMBLY AND ASSEMBLY TO INSTALL THE NEW HP POPPET SEAT, CHECK THE PROCEDURES DESCRIBED IN THE MARES MAINTENANCE MANUAL SECTION RELATED TO FIRST STAGE POPPET SEAT REPLACEMENT.
